# Home Inspection Report

For  
1234 Somewhere Drive Anytown, NC

**Inspection Date:**  
**May 25, 2012**

**R. Edwin Bass, Jr.**  
**Bass Home Inspections LLC**

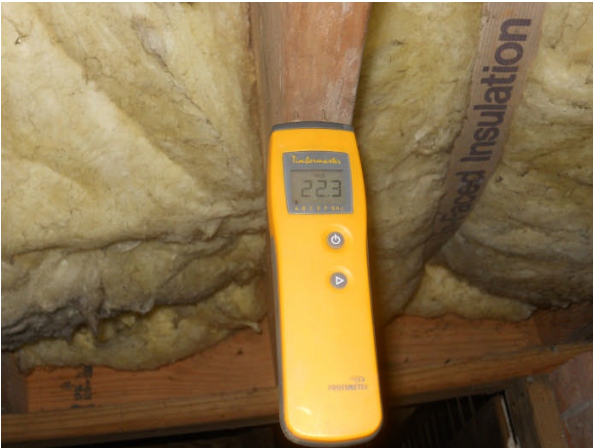
12. There is evidence of water infiltration in the crawlspace- there was water staining on the piers and foundation walls, the ground was muddy, and some water trenches were noted on the foundation walls. In addition, the moisture reading in the floor joists was high. Recommend further evaluation by a water proofing contractor.

Moisture reading high in floor joists

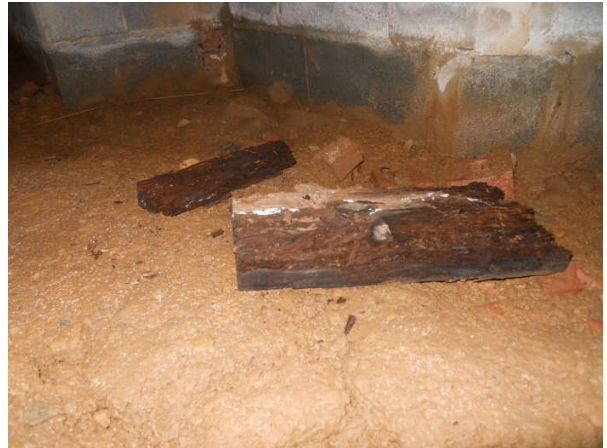
Additional Comments: There is some wood debris in the crawlspace that needs removing. It can attract wood destroying insects.

Wood debris in the crawlspace

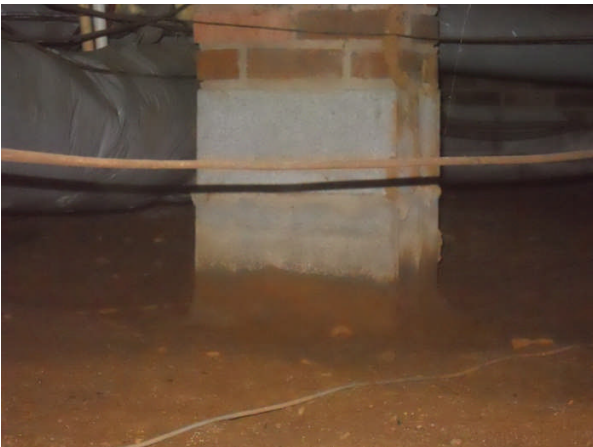
Water staining on piers

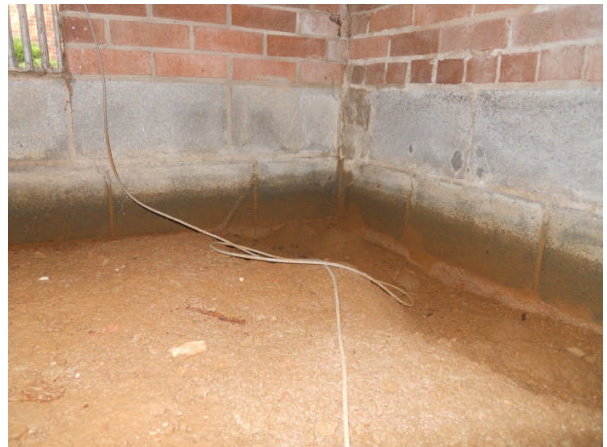
Water staining/ trench at front left corner

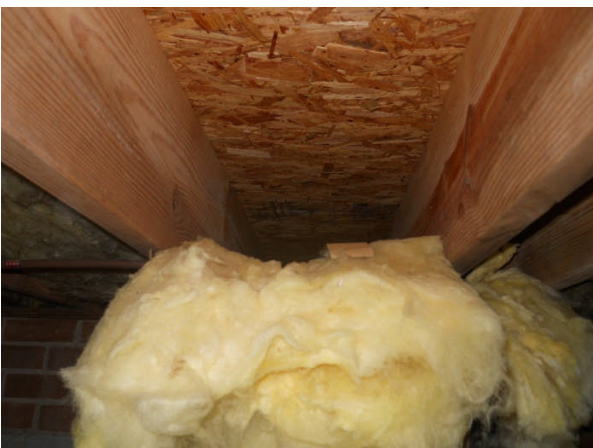
10. There are 1-2 pieces of fallen/ damaged insulation located at the right side of the crawlspace that need replacing/ putting back up between the floor joists. Recommend having an insulation contractor repair.

Fallen/ missing insulation

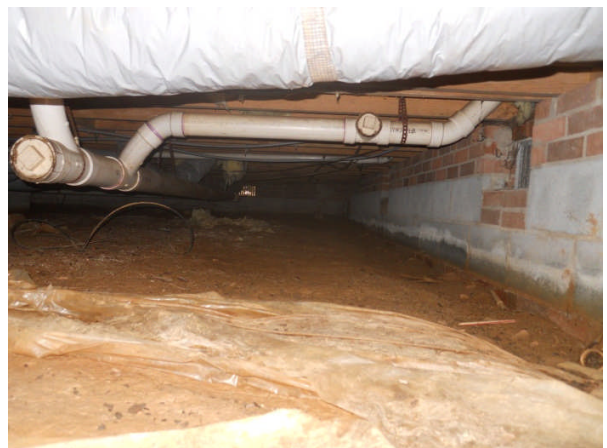
13. The vapor barrier was missing in large areas of the crawlspace, and what is there is damaged. A vapor barrier controls the moisture emitted from the ground. Recommend having a qualified contractor install a vapor barrier in the crawlspace after the water infiltration issue is addressed.

Missing vapor barrier

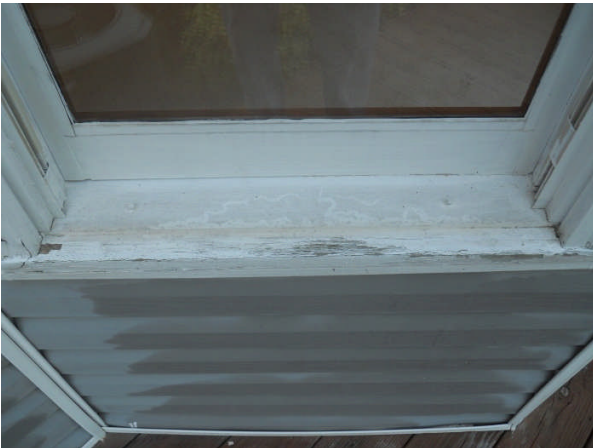
5. The top and right side wood trim on the garage door is damaged and needs replacement.
6. The majority of the windows will need painting. Recommend having a qualified painting contractor repair.

Rear window needs painting

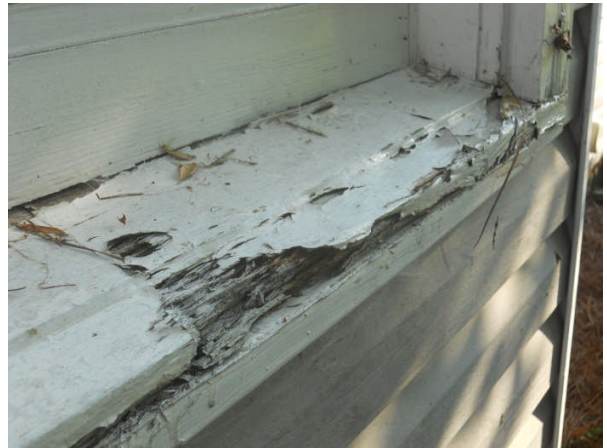
3. There were damaged window stools noted on the left side window and the front upstairs bay window. Recommend having a qualified contractor repair.
4. The rear living room door to the deck is water damaged at the bottom. It will need repair/ replacement. Recommend having a qualified contractor repair.

Damaged window stool on left side window

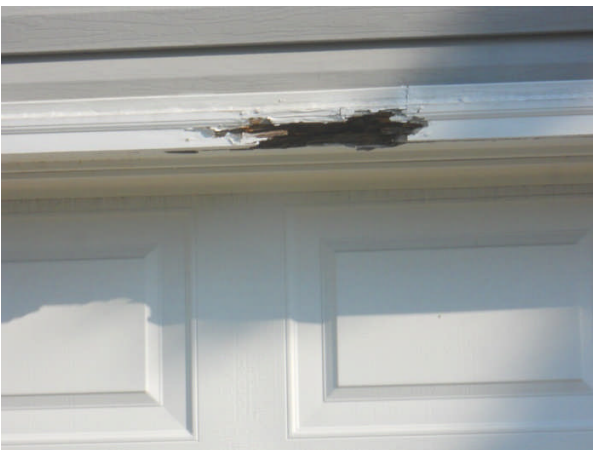
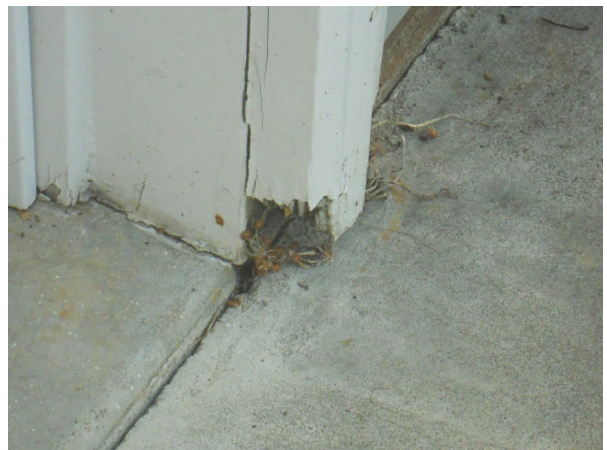
Damaged wood trim on garage door

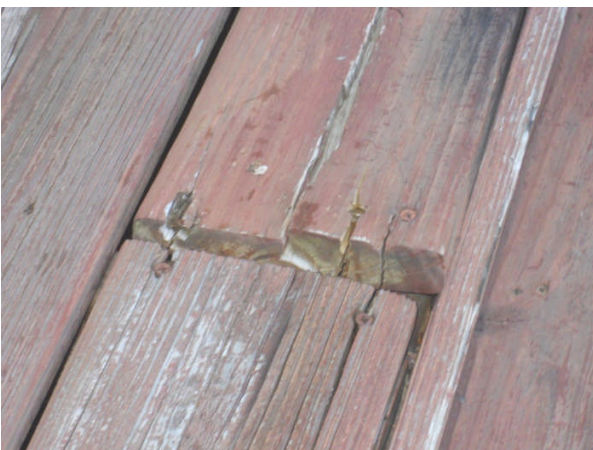
9. There were several loose decking boards noted that need securing, and the deck will need staining. In addition, recommend a handrail on the right side of the deck- it is over 30 inches high and considered a safety issue.  
The deck was nailed into the house band as opposed to being bolted through it. This is considered a safety issue. The deck could pull away from the house under heavy loads. Recommend repair by a licensed general contractor.

Loose decking boards

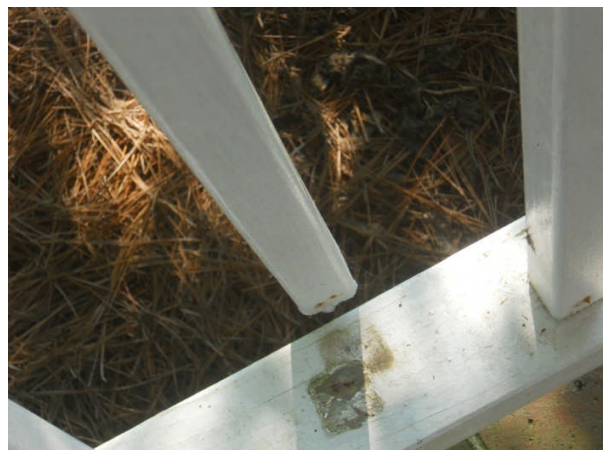
12. There were several loose pickets noted on the front porch handrail that need securing.

Loose pickets on front handrail

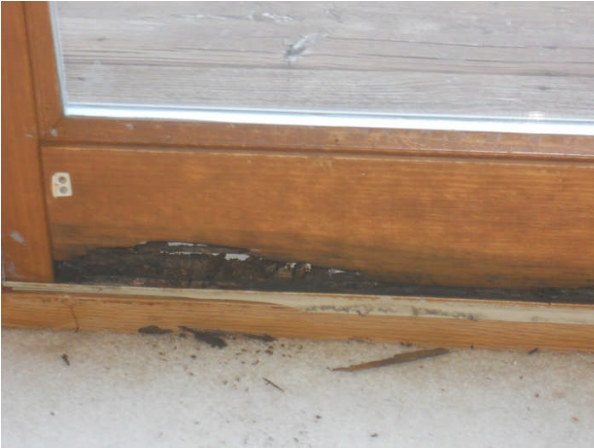
Damaged living room door

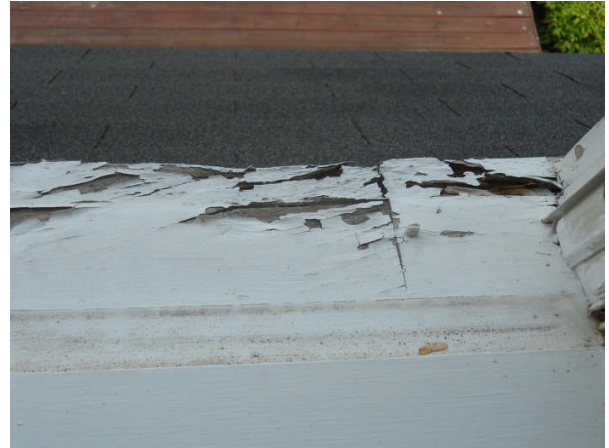
Damaged window stool on upstairs bay window

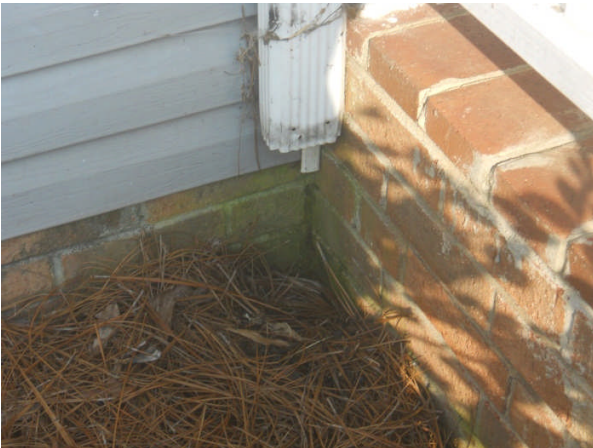
8. The front porch downspout is missing its bottom elbow and needs a drain pipe to help divert roof water away from the foundation.  
The right side front downspout is not connected to its drain pipe.

Missing elbow/ drain pipe at downspout

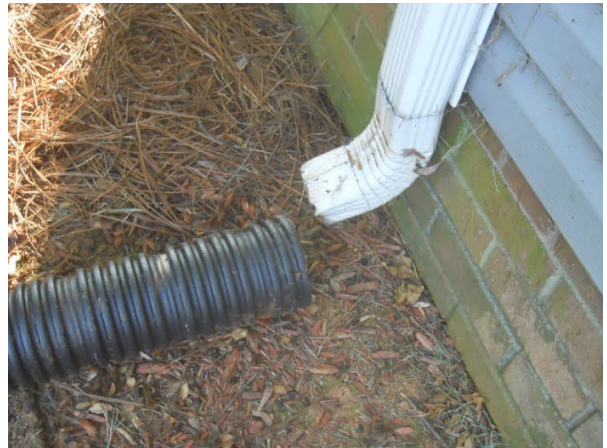
Downspout not connected to drain pipe

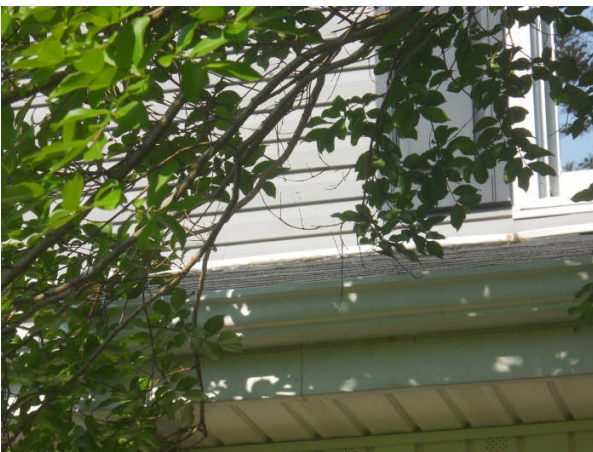
1. Recommend trimming the tree limbs away from the front porch roof shingles. The limbs will damage the shingles.
  7. The right side breezeway gutter slopes away from the downspout and is loose from the fascia board. Recommend having a qualified contractor repair.

Tree limbs need trimming back

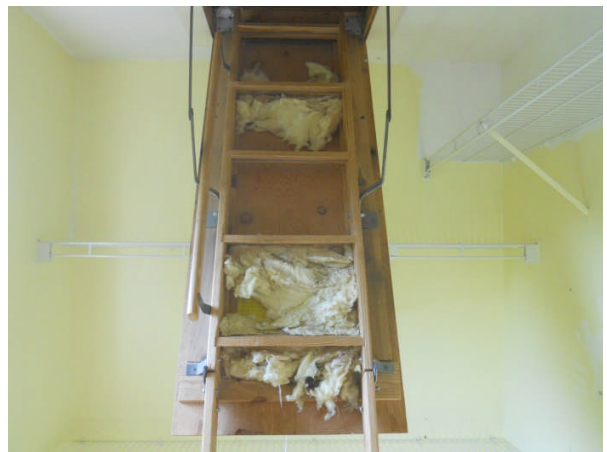
- Additional Comments: The attic pull down stairs could use a piece of batt insulation under them to improve energy efficiency.

Attic pull down steps need new batt insulation

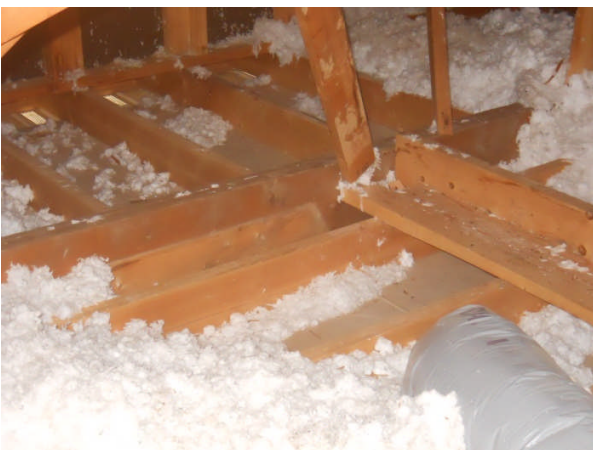
11. There is missing insulation at the front left corner and rear right corner of the attic. The insulation has settled in other places. Recommend having an insulation contractor repair.

Missing insulation in attic

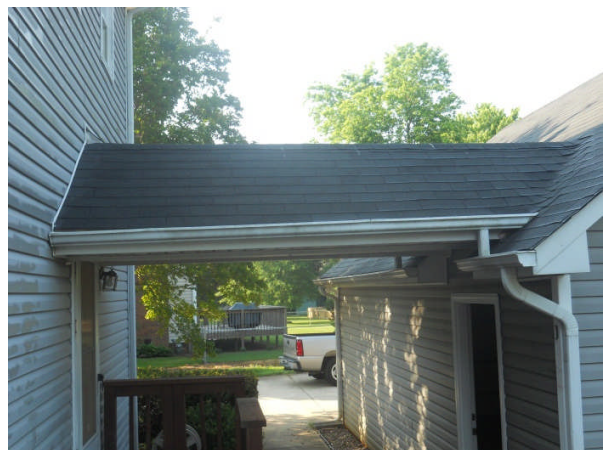
Breezeway gutter slopes the wrong way

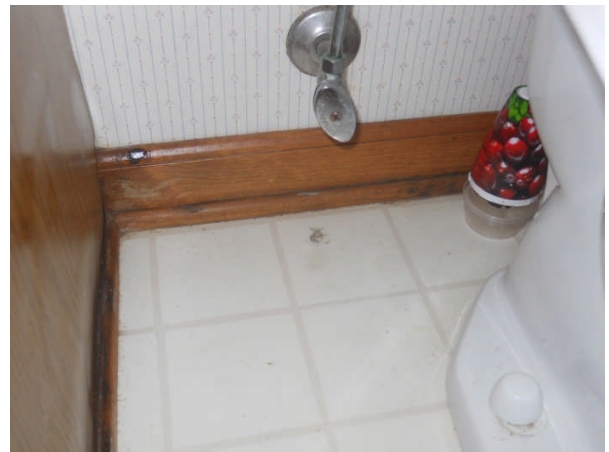
6. The shut off valve for the downstairs half bath toilet leaks. Recommend having a licensed plumbing contractor repair.

Downstairs hall bath toilet shut off leaks

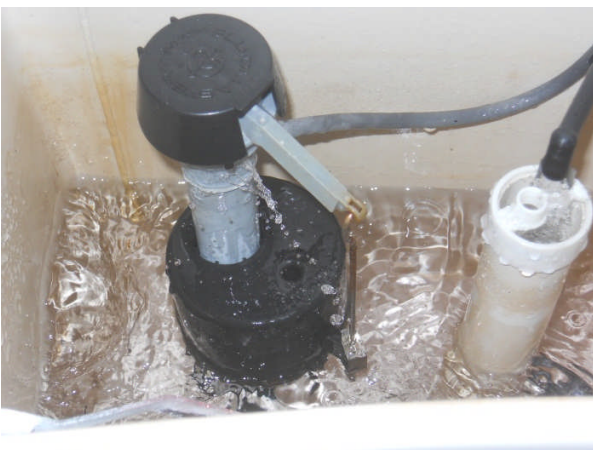
The downstairs half bath toilet needs a new flush valve kit in it- it is leaking.

Flush valve kit in toilet need changing

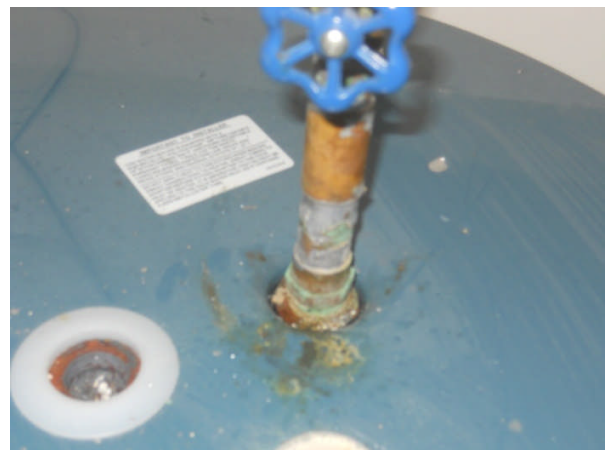
The water shut handle for the water heater has some water under it and the handle was damp. Recommend further evaluation by a licensed plumbing contractor.

Water heater handle has some water at it

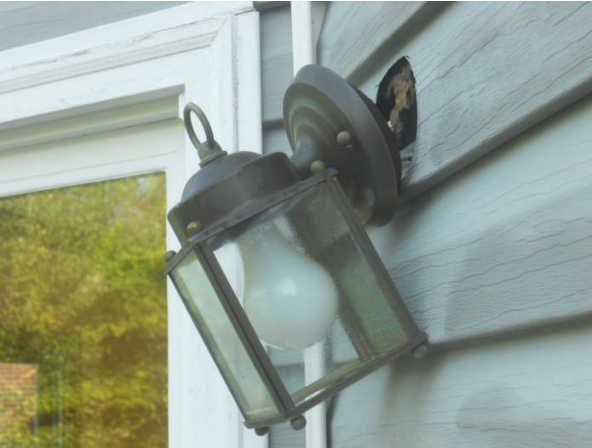
The rear deck exterior light is not secured to the house and there is exposed wiring at it. It needs securing.

Rear deck light is not secured to the house

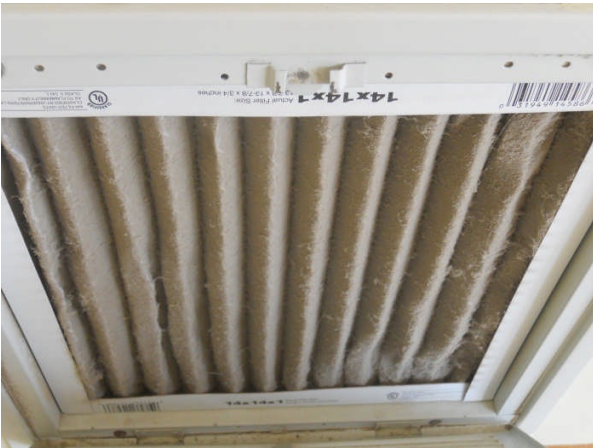
The air filters are dirty and need changing badly.

Air filter needs changing

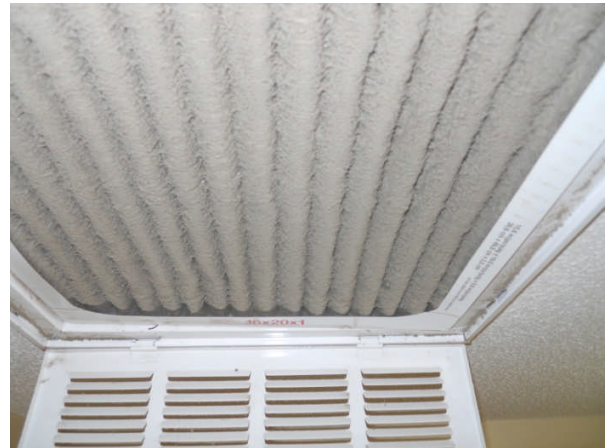
Air filters need changing

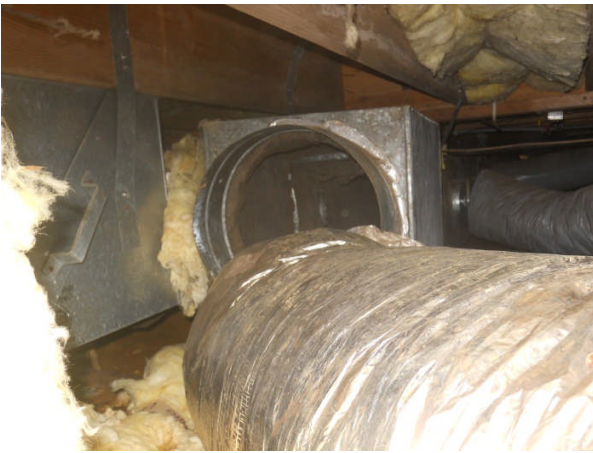
11. The gas pack air duct is disconnected in the crawlspace- it is blowing its air into the crawlspace. Recommend having a licensed mechanical contractor repair.

Disconnected air duct in crawlspace

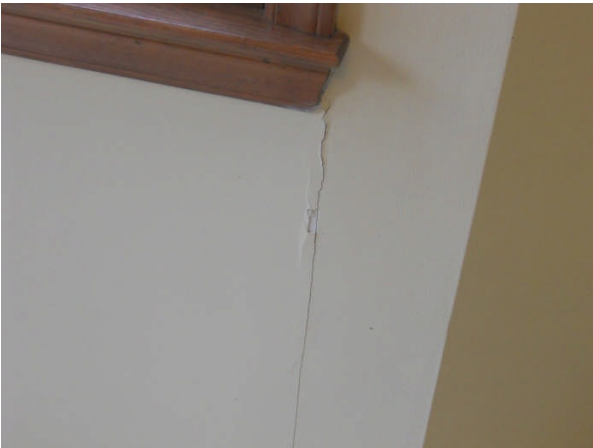
1. There were cracks noted in the sheetrock walls below the bay windows that will need patching.
3. There was damaged vinyl flooring noted in the master bathroom floor.
8. There was a broken window lock noted on the left side master bedroom window that will need replacing.  
The doorknob on the upstairs front right bedroom closet does not work and will need repair/ replacement.
15. The downstairs smoke detector is missing- this is considered a safety issue. Recommend replacing the upstairs smoke detector- it has some age on it. Smoke detectors should be replaced every 4-5 years as per the manufacturer's recommendations.

Crack under rear living room bay window

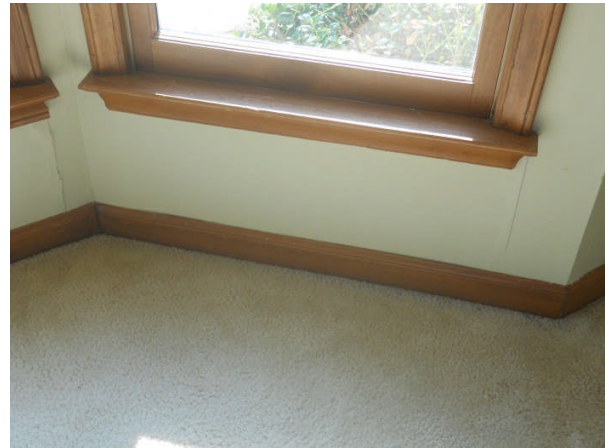
Crack under front downstairs bay window

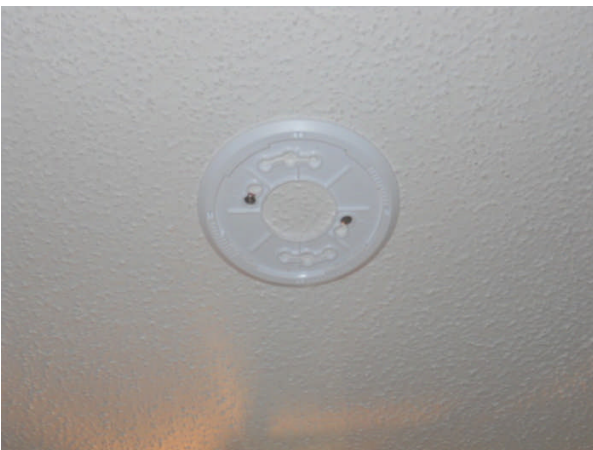
Missing smoke detector downstairs

15. The downstairs smoke detector is missing- this is considered a safety issue. Recommend replacing the upstairs smoke detector- it has some age on it. Smoke detectors should be replaced every 4-5 years as per the manufacturer's recommendations.

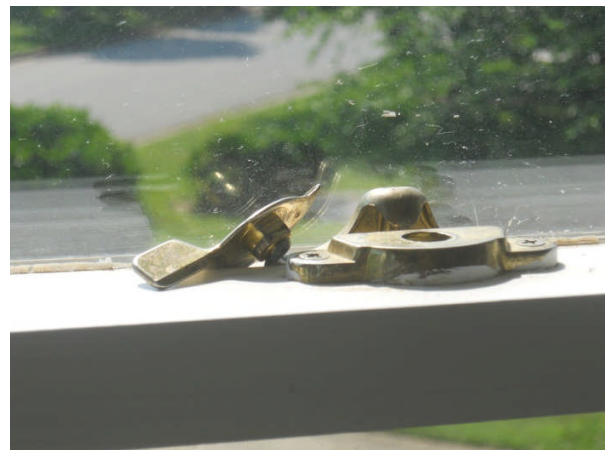
Broken window lock

1. There were cracks noted in the sheetrock walls below the bay windows that will need patching.
3. There was damaged vinyl flooring noted in the master bathroom floor.
8. There was a broken window lock noted on the left side master bedroom window that will need replacing.

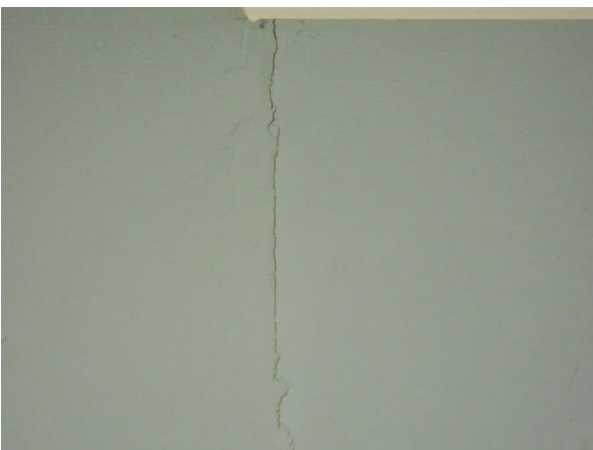
Crack under upstairs bay window

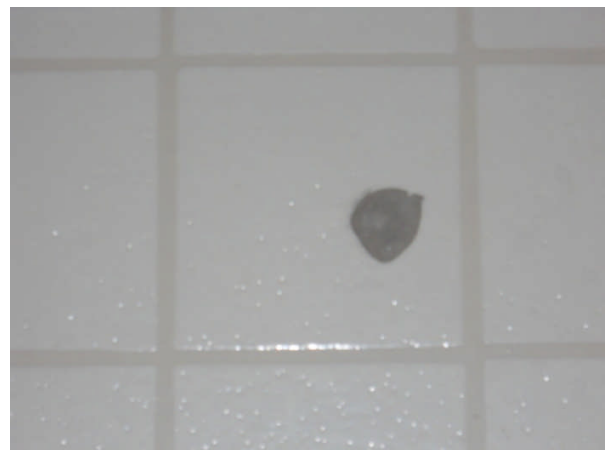
Damaged master bath vinyl flooring

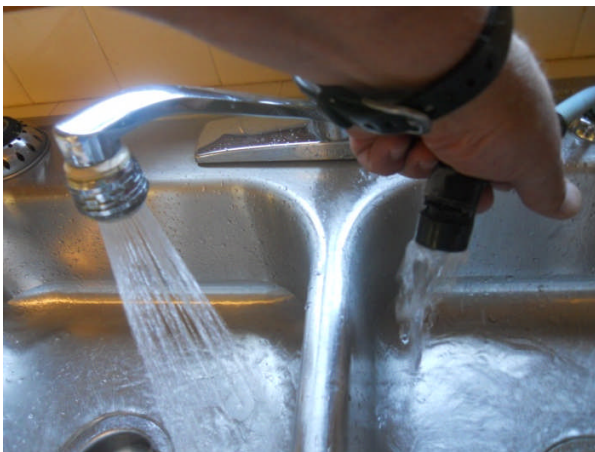
- The vegetable sprayer does not work and the kitchen sink faucet is loose. Recommend having a licensed plumbing contractor repair.
- 
- 
- 
- The microwave tester never lit up when testing the microwave. The microwave may not work. Recommend further evaluation by an appliance repair contractor.

Vegetable sprayer does not work
